Case Studies of Grid-Connected Photovoltaic Systems, Vol. 2

Technical Report

Final Report, March 2003

EPRI PEAC Corporation

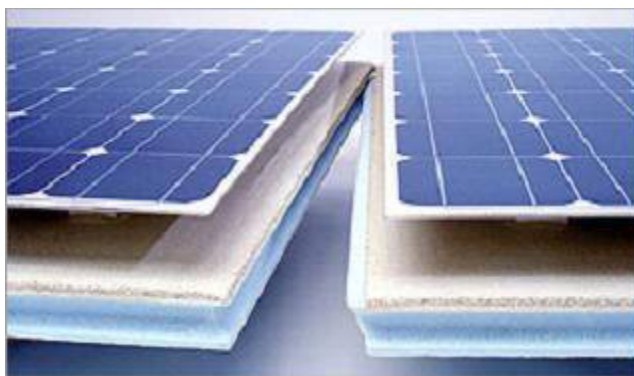
Figure 3-3
PowerGuard® Insulating Rooftop Solar Panels from the PowerLight Corporation

PowerGuard tiles are formed by bonding a PV module to a sheet of polystyrene insulation as shown in Figure 3-3. The tiles are interlocked with each other through grooves along the edges and lay flat on the roof (tilt angle of 0 degrees) to form the array. The tiles typically have insulation values greater than R-10 and therefore provide protection and additional insulation to the roof. The additional insulation of the PowerLight tiles helps increase the overall energy efficiency of the building by minimizing heat loss or gain depending on the season. The PowerGuard tiles are laid directly onto new and existing rooftops without mechanical fastening. They are self-ballasting and remain stable in wind speeds up to 140 mph.

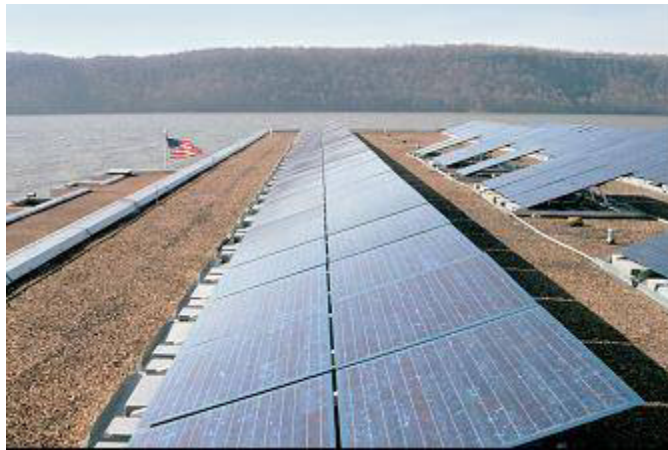
Figure 3-7
Roof Mounted PV Installation at the Yonkers Wastewater Treatment Facility

The Yonkers (New York) Wastewater Treatment Facility operates a 100-kW PV system installed by NYPA. The array, shown in Figure 3-7, consists of 924 Solarex MSX-120, 120-watt polycrystalline silicon modules connected in 77 strings and wired in a mono-polar fashion. Each string is comprised of 12 modules connected in series to create a string voltage of 420 Volts. Six strings are wired in parallel in each of 13 combiner boxes. The one-line electrical diagram for the PV system at the Yonkers Wastewater Treatment Facility is shown in Figure 3-9.

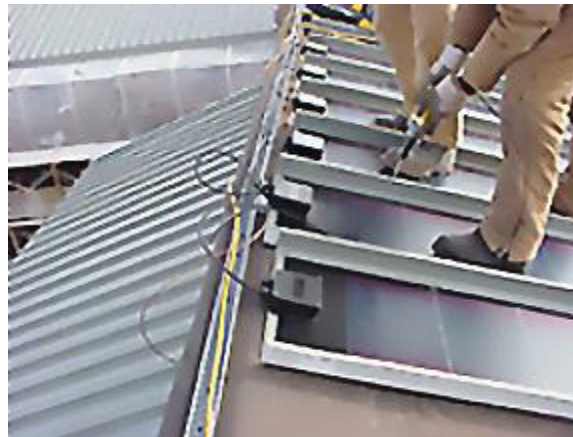
Figure 4-2
Installation of PV Standing Seam Metal Roof on Mary Ann Cofrin Hall

A 12.8-kW PV array is incorporated into the standing seam metal (SSM) roof of the south-facing wing of Mary Ann Cofrin Hall. Both traditional and BIPV standing seam metal roofing systems use vertically sloping metal trays that snap together along raised edges to form the roof. The BIPV metal roofing from the United Solar Systems Corporation goes one step further by gluing or laminating thin-film amorphous-silicon triple-junction photovoltaic modules to the metal trays. The BIPV metal roofing provides the same protective functions as tradition SSM but presents the added benefit of producing electricity. The installation of the United Solar Systems Corporation standing seam metal roofing product is shown in Figure 4-2 and Figure 4-3. The array is composed of 100 of the 128-watt panels (SSR-120) covering 2,300 square feet of roof space. The SSM roof array feeds one Trace Engineering PV15208 inverter.

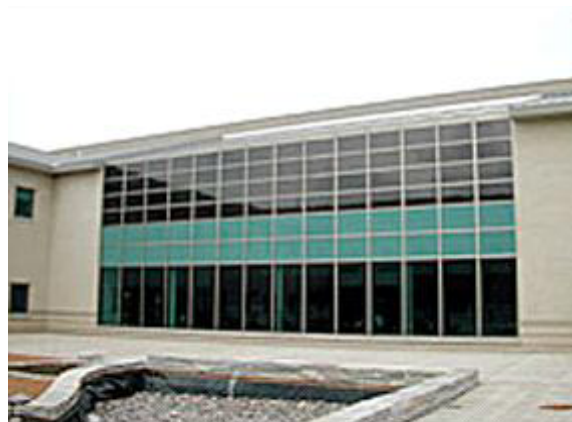
Figure 4-4
Exterior View of the Vision Glass Wintergarden at Mary Ann Cofrin Hall

In addition to the BIPV standing seam metal roof, a 10.8-kW array of photovoltaic vision glass is used in the Wintergarden of Mary Ann Cofrin Hall as shown in Figure 4-4 and Figure 4-5. Vision glass is manufactured by replacing the exterior glass panel of a double-pane glass window with a thin-film, semi-transparent photovoltaic module. Each window or module is then wired together in the same manner as any other PV array. BP Solar laser etched their MST-43LV 43-watt modules to create the required transmittance. The semi-transparent solar modules were incorporated into architectural glass panels by Viracon Inc. Finally, a total of 252 vision glass modules were installed in a standard Kawneer Company PowerWall™ 1600 to create an array that spans 2,000 square feet. Each vision glass module uses 13 layers of thin film with a total film thickness less than a sheet of paper. The array feeds a total of four Trace Engineering 2500 Watt ST-XR inverters.

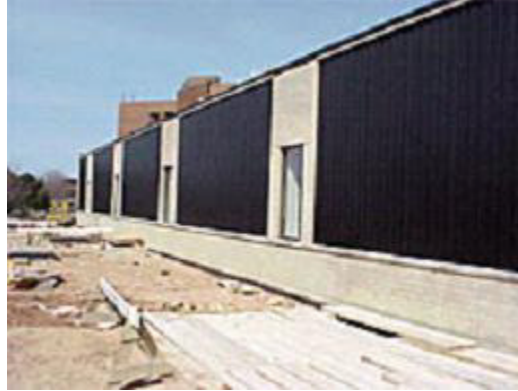
Figure 4-6
The South Facing Wall of Mary Ann Cofrin Hall Incorporates Solar Wall Heating Technology

SolarWall technology is used to pre-heat the HVAC intake air during the winter months. The SolarWall is an unglazed porous solar collector that absorbs heat energy from the sunlight shining on it. In the case of Cofrin Hall, one south-facing wall is a 2,256 square foot transpired solar collector or SolarWall as shown in Figure 4-6. The HVAC intake air enters the wall at vents near the ground and exits the wall to the air handlers through vents at the top. While passing through, the air is warmed by the collected solar heat.

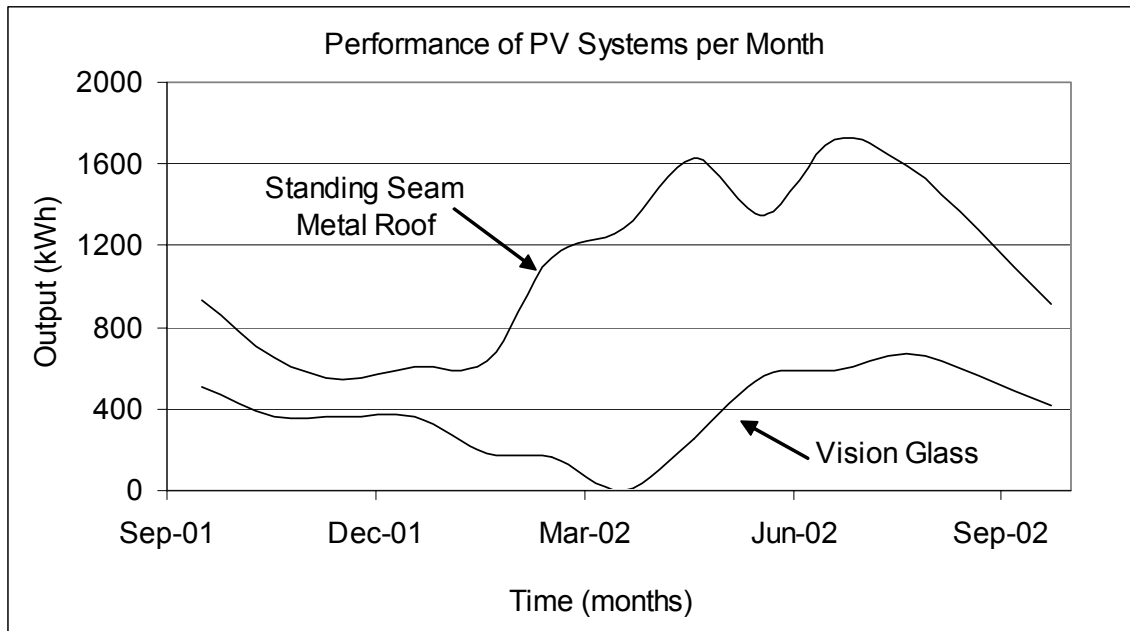
Figure 4-7
PV System Performance from October 2001 through October 2002

Figure 4-7 and Table 4-5 show the outputs of both the roof and vision glass systems from October 2001 until October 2002. Unfortunately, the vision glass system was plagued by inverter failures during much of its first year of operation. The inverter failures are discussed in more detail in the Equipment Failures and Maintenance Issues Section of this chapter.

The output for the standing seam metal roof system shown in Figure 4-7 exhibited a downturn in June 2002. At the time of writing of this report, December 2002, it is unclear whether the system output was actually reduced for the month or if there was a data acquisition error.

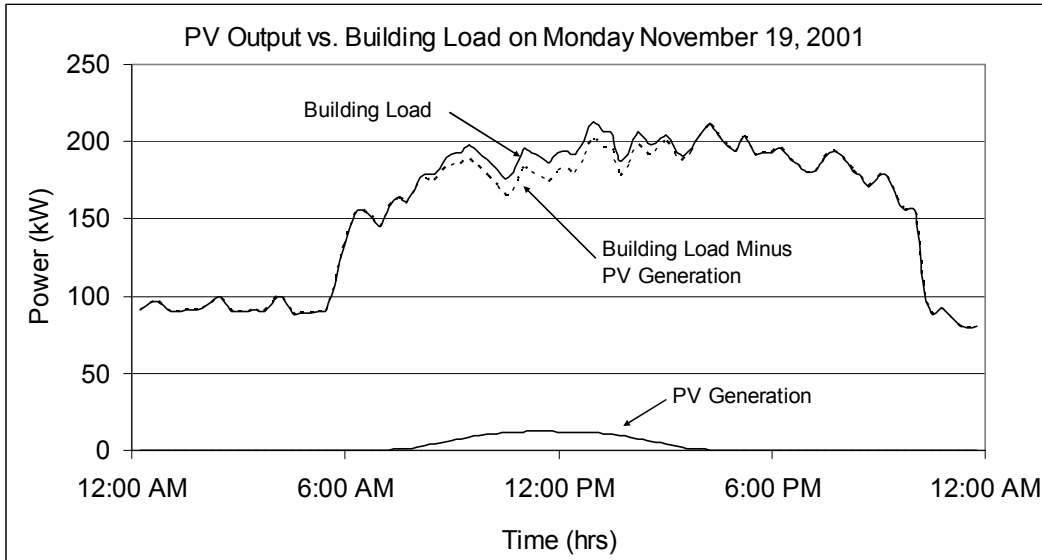
Figure 4-8
Typical Daily Building Load and PV System Output

The ability of the PV systems to load match the power demand of Mary Ann Cofrin Hall is illustrated in Figure 4-8. The peak output of the PV systems, equaling approximately 10% of the building load, did occur during a time of peak building demand. However, because of the type of use Cofrin Hall experiences it exhibits a rather long period of peak use. The building power demand jumps up around seven o'clock in the morning and remains at an elevated level until nearly 10 o'clock in the evening. This load shape is reasonable for a university building because of its varied class schedule, many computer facilities, and the propensity of college students to work at odd hours of the day.

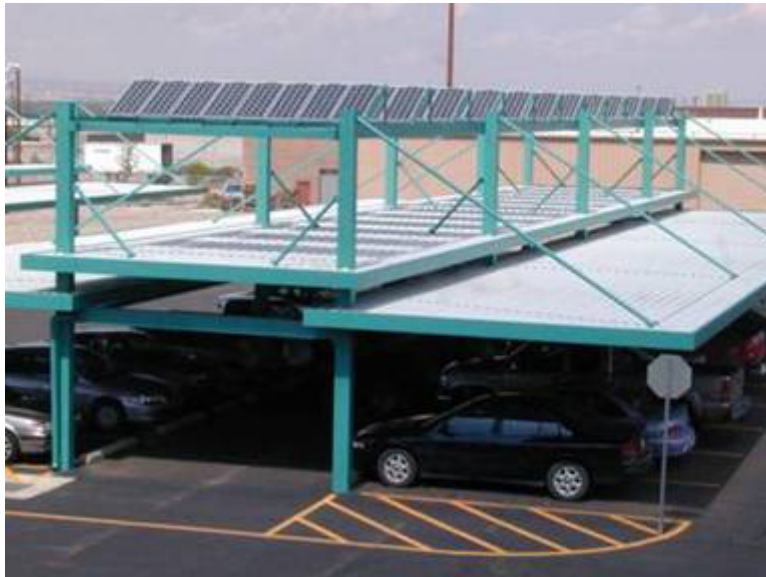
Figure 5-1
Parking Structure Photovoltaic System at the PNM Facility in Albuquerque, New Mexico

The 5-kW photovoltaic array consists of two sub-arrays of PV modules mounted on top of the parking structure at a fixed tilt angle of 30° (Figure 5-1). Each subarray is comprised of 48 BP Solar BP 270F 70-watt monocrystalline modules divided to form two strings of 24 modules. Each subarray feeds a SMA Sunny Boy 2500 inverter shown in Figure 5-2. Figure 5-3 is a one-line electrical diagram of the whole system.

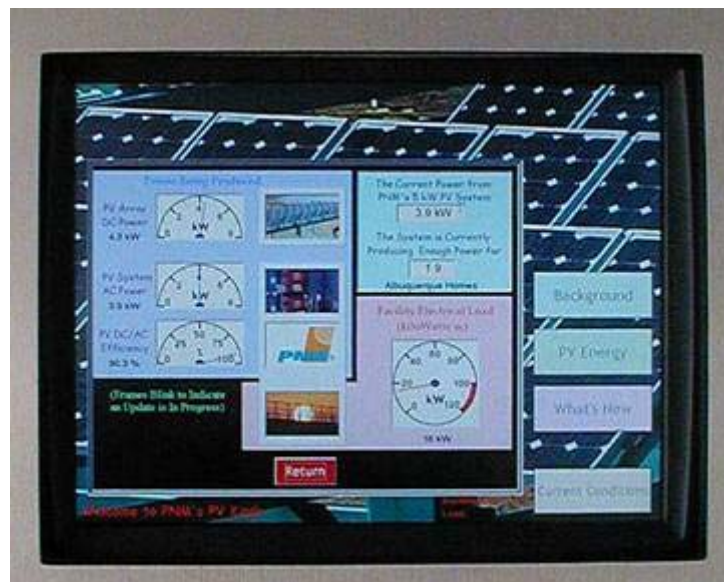
Figure 5-4
Touch-Screen of the Information Kiosk for the PNM Parking Structure Photovoltaic System

The data acquisition system (DAS) was designed and installed by the Southwest Technology Development Institute at New Mexico State University. The data collected by the DAS can be accessed from remote locations by telephone line or viewed on a touch-screen kiosk in the building lobby (Figure 5-4). The parameters measured by the DAS are shown in Table 5-1.

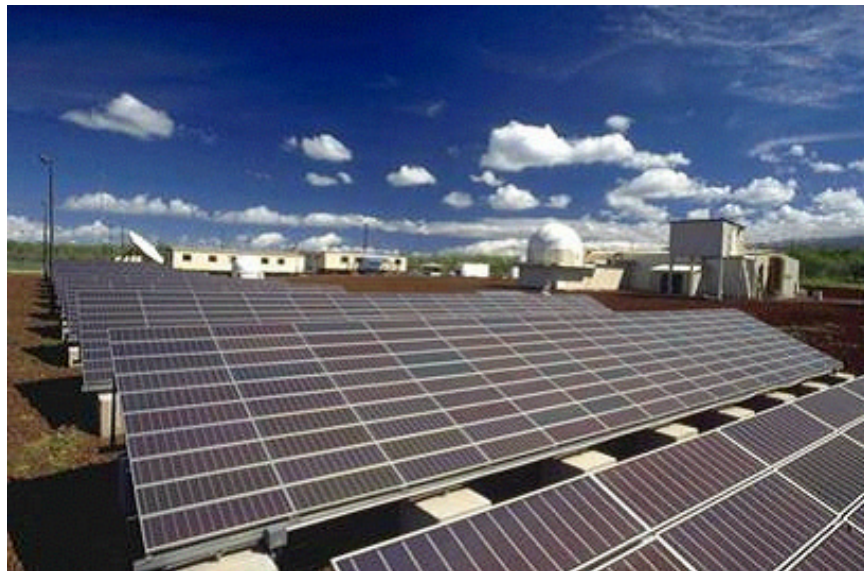
Figure 6-1
PVUSA 20-kW Facility in Kihei, Maui

The 20-kW PVUSA (Photovoltaics for Utility-Scale Applications) system is located on a parcel of land within the Ulupalakua Ranch in Kihei, Maui. This ground-mounted, grid-connected system is owned by the State of Hawaii under the Department of Business, Economic Development and Tourism (DBEDT). Maui Electric Company, Ltd (MECO) operates and maintains the facility. MECO is a subsidiary electric utility of Hawaiian Electric Company, Inc. (HECO) that serves the islands of Maui, Molokai, and Lanai. The Kihei PV facility is shown in Figure 6-1.

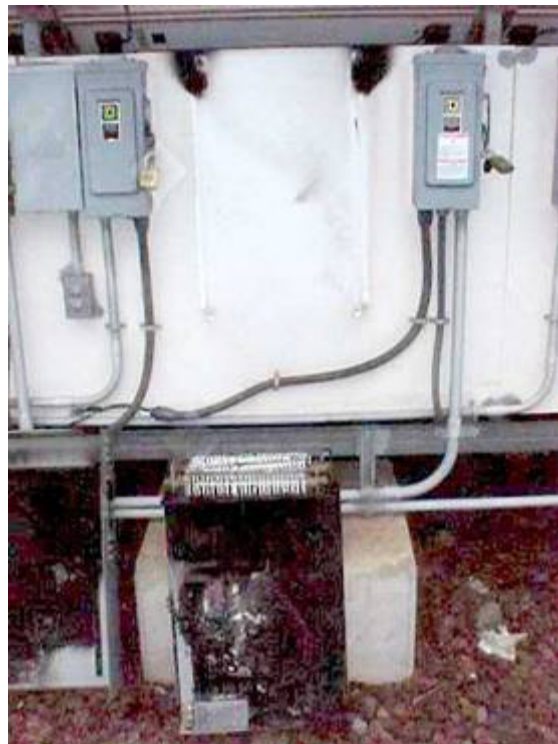
Figure 6-4
Photograph of the Board to Which the Damaged Omnicion Inverter was Mounted
(Note the two Burn Marks at the Top of the Board)

- Fire damage was contained primarily within the inverter with some blackening present on the board to which the damaged inverter was mounted. Refer to Figure 6-4. According to S&C Electric Company —S&C acquired Omnion Power Engineering Corporation in 1999— the temperature inside the enclosure was estimated to be at least 125°C (257°F) based on the condition of the capacitors.

The damaged inverter and information on the PVUSA system were sent to S&C for evaluation for investigation, but the investigation was inconclusive as to the cause of the fire. Inspections of the PVUSA system did not uncover any suspicious array or wiring arrangements and the occurrence of lightning around the time of the fire was highly unlikely as there was no storm activity in the vicinity during the period of time within which the inverter fire occurred. Based upon the investigation, the inverter itself cannot be ruled out as the cause of the inverter fire at the Kihei PVUSA facility.

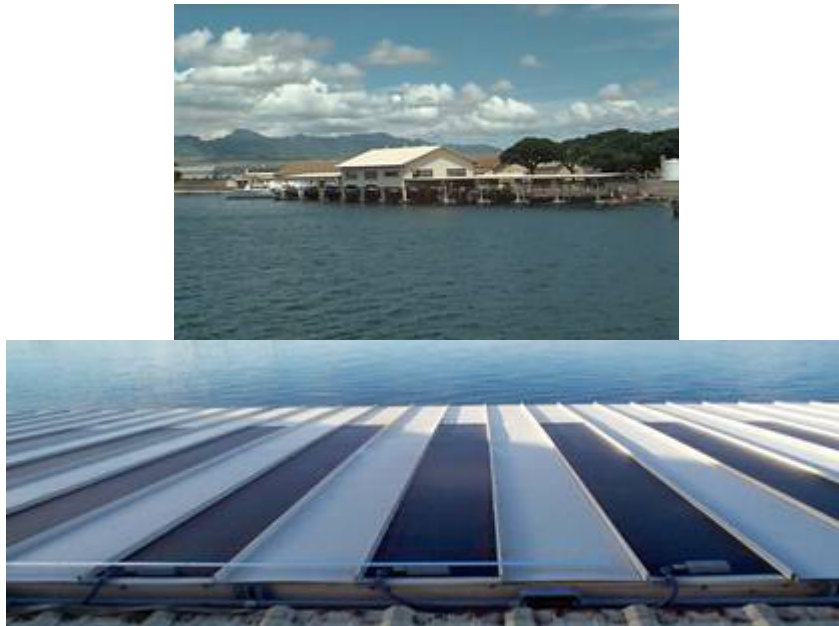
Figure 7-1
Ford Island 2-kW BIPV System – Boat House (top photo) and Standing Seam PV Panels on the Roof (bottom photo)

A 2-kW building-integrated photovoltaic (BIPV) system was installed on Building 44 of the U.S. Navy’s Ford Island Boat House in Pearl Harbor (Oahu, Hawaii). The Ford Island BIPV facility is shown in Figure 7-1. The system was installed under a collaborative project between the Commander Navy Region Hawaii, Hawaiian Electric Company, Inc. (HECO), University of Hawaii at Manoa School of Architecture (UH SOA), and the National Renewable Energy Laboratory (NREL).
